PALM STREET WATER PLANT CONDITION ASSESSMENT

City of Huntsville

July 31, 2015

FREESE AND NICHOLS, INC.
11200 Broadway Street
Offices West, Suite 2332
Pearland, TX 77584
832-456-4700

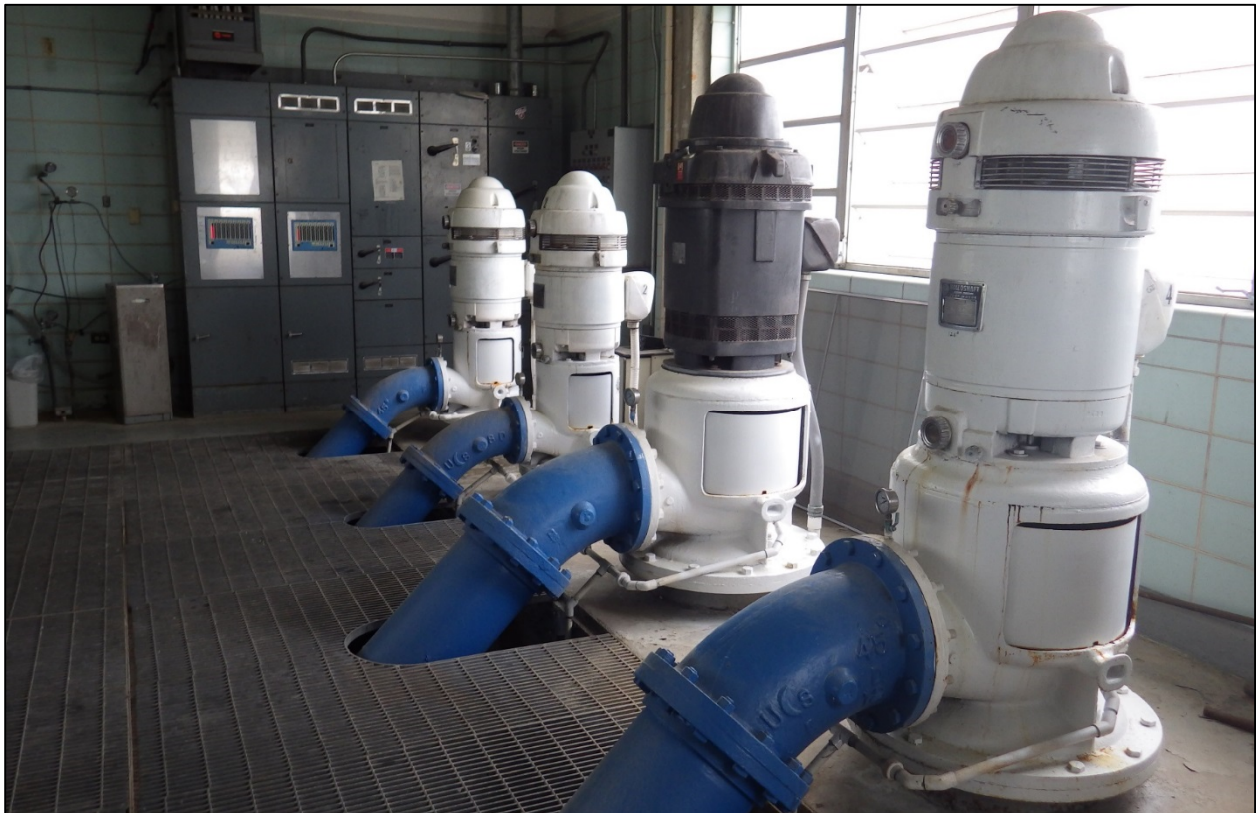
The Old Pump Station was built in 1960 and consists of four vertical turbine pumps. The two smaller pumps have a design capacity of 1,000 gpm while the two larger pumps can pump 2,000 gpm. There is a space allocated for a 5th pump in the pump station originally intended for future expansion. Only one motor has been replaced on the pumps since the original installation and the pumps have not been pulled for service in 14 years. The pumps are all original.

The pump station building is small and does not have an HVAC system. There is a 1.5 ton overhead crane for pulling pumps but due to the low ceiling it is difficult to pull pumps or motors and have space to move within the pump station. Additionally, there is no truck access at the entrance to the pump station.

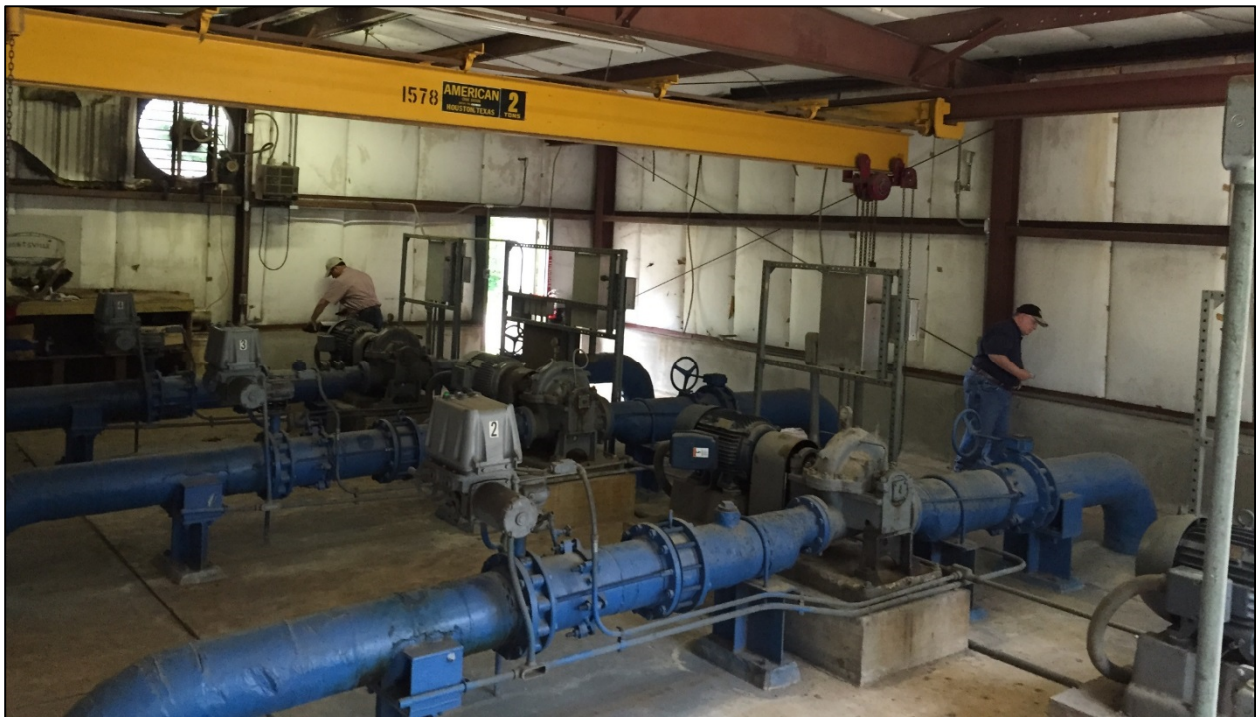
The New Pump Station was built in 1983 consists of four horizontal split case pumps each with a design capacity of 1,750 gpm. Generally the City's operators have had more problems with this pump station than the old pump station. Three of the four pumps have been replaced since the original installation. There is a 2 ton overhead bridge crane for pulling pumps and equipment and good access for vehicles to enter through double sliding doors to the pump station.

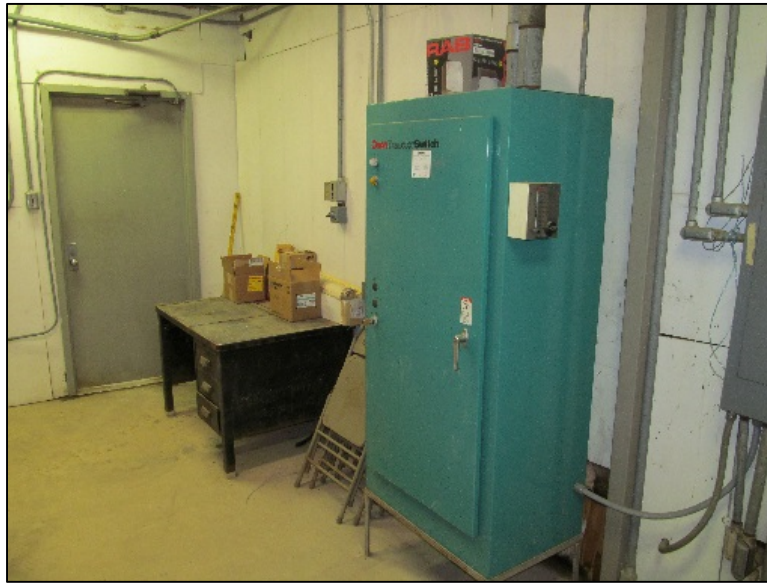
Utility and backup generator power comes through an automatic transfer switch. The generator and Automatic Transfer Switch (ATS) were installed in 1984 and the generator has failed. A temporary generator has been installed. The automatic transfer switch currently works but is no longer supported by the manufacturer and replacement parts will not be available when current stock is sold out. A failure

of the ATS could leave the pump station out of service for an extended period of time. However, the City has recently begun a project to replace the generator. Therefore the condition rating is very good.

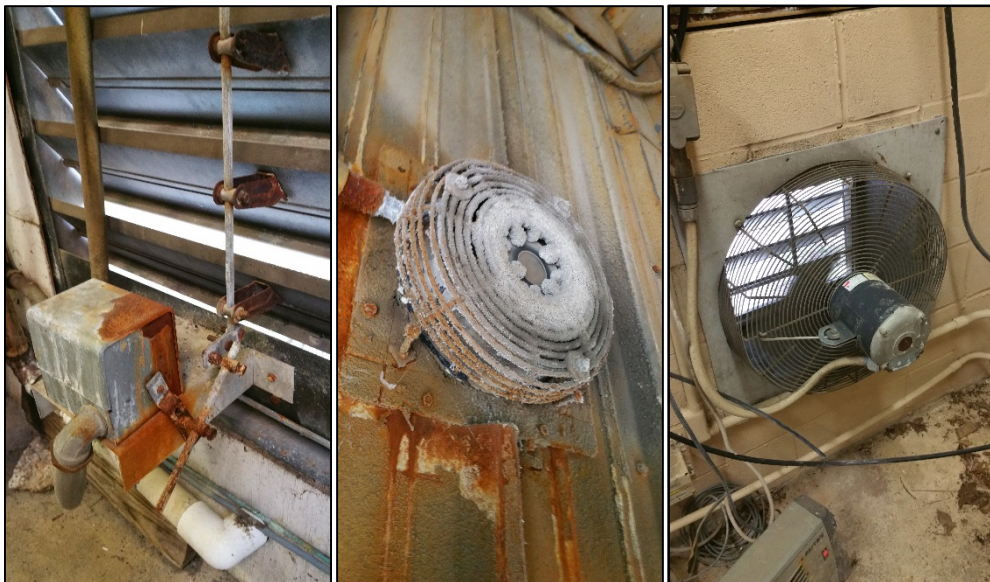
The ventilation system in the fluoride room consists of a wall-mounted exhaust fan, door mounted louver, and residential style grille installed in the wall above the door. The overall condition of the equipment is poor. The exhaust fan is highly corroded and almost no airflow is being allowed through. The grille above the door is not properly installed, is not the proper type, and allows water penetration

It is recommended the exhaust fan should be replaced immediately. Also, the grille high in the wall should be replaced with a properly installed industrial grade wall-mounted louver.

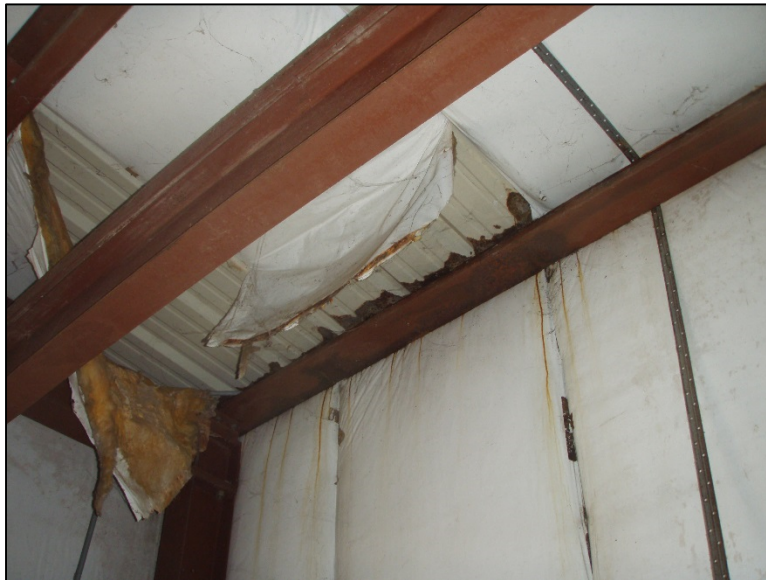
The fluoride and chlorine building is a pre-engineered metal building with one-half of the building enclosed with masonry walls and metal wall panels. The other half of the building is open with canopy roof. The exterior exposed structural steel columns show signs of mild corrosion and the paint coating has failed at bottom of columns and base. Inside the chlorine room, there is mild rusting on the interior face of metal wall panels and steel framing. There are minor dents on exterior face of metal wall panels.

The electrical building is a pre-engineered metal building and is in good condition. There are minor dents on exterior face of metal wall panels.

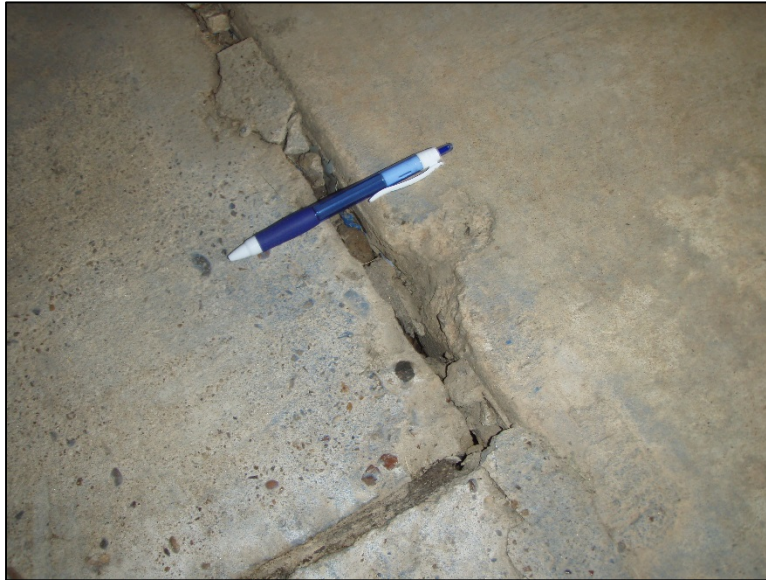
For the fluoride and chlorine building, from visual observations, the concrete foundation/slab appears to be in good condition.

For the electrical building, from visual observations, the concrete foundation/slab appears to be in good condition.

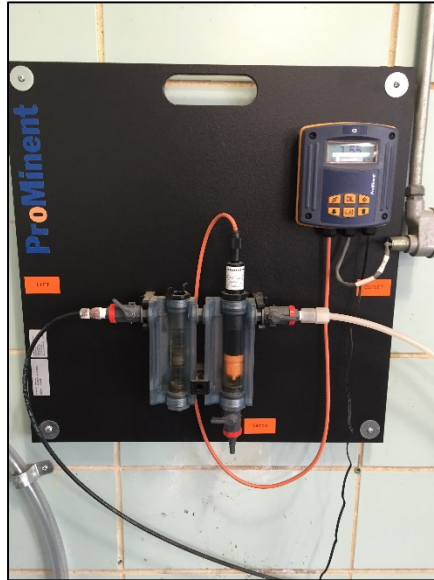
While the existing analyzer is in good condition, the City prefers to have a new chlorine analyzer at the new pump station similar to the ProMinent Chlorine Analyzer that was recently installed at the old pump station.

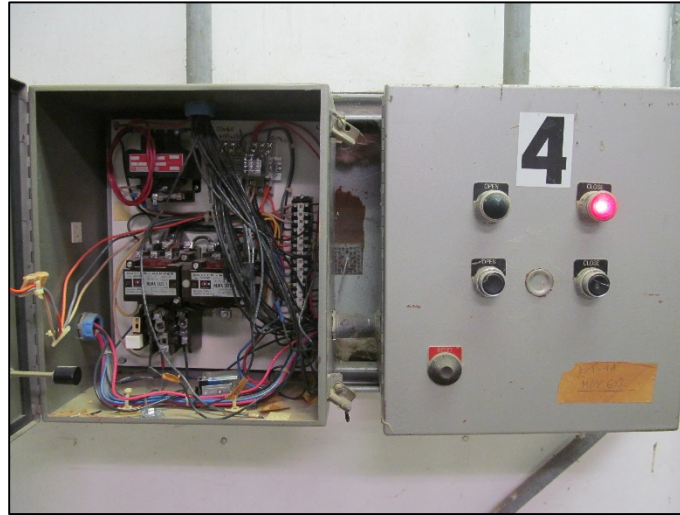
The pumps are controlled from either the old pump station or from a control station located in the new pump station. Control stations can wear out over time. Replacement parts are readily available. Modifications to the controls for pump number 1 have left little documentation for wiring causing potential extended outages due to troubleshooting.

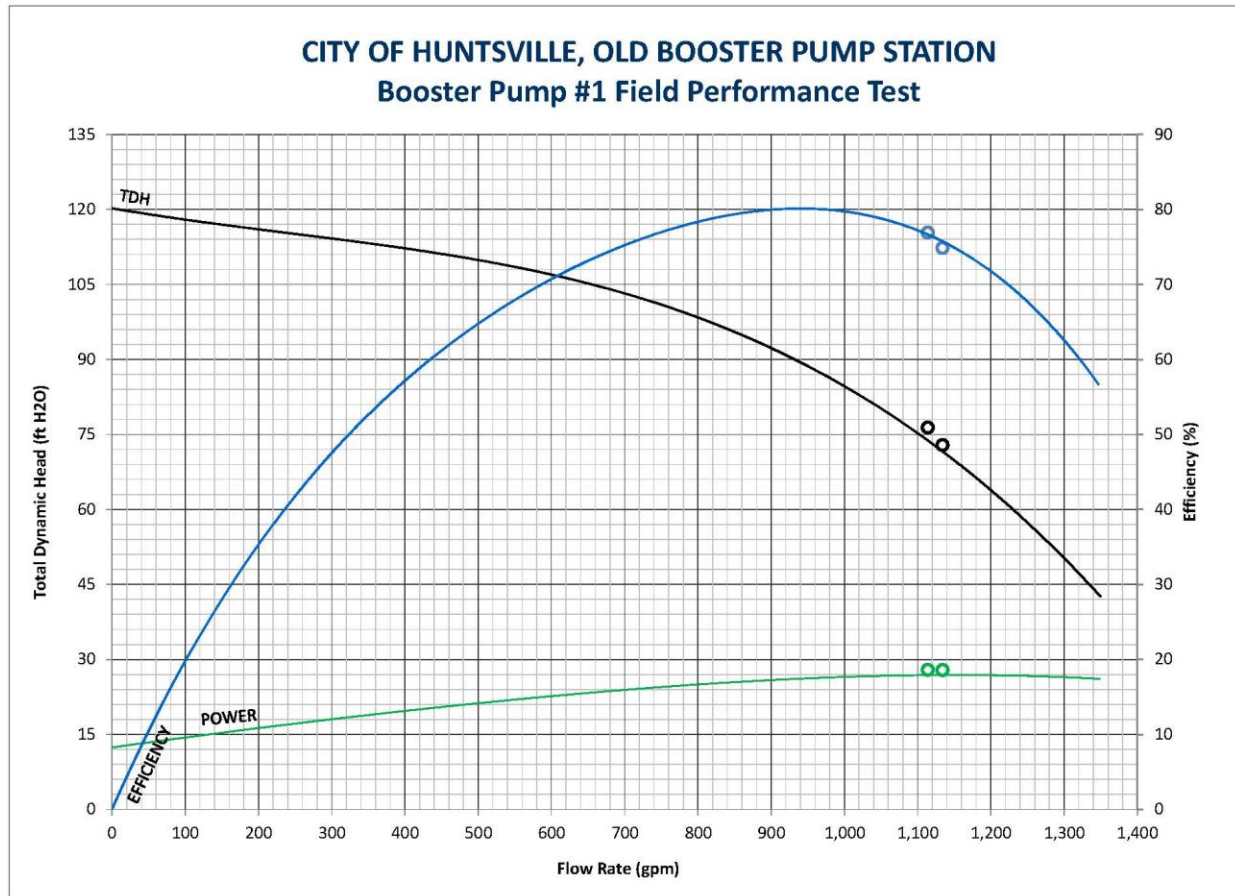
The pump performance test data (hydraulic and electrical) shows the two (2) field test points are shown in the same color as each curve. The instrument values are recorded in concert with one another. The data is reduced to result in the points that show up in the composite curve chart. The data is speed corrected to the catalog curve test speed so that the test data can be compared.

Figure 4: Old Booster Pump Station, Booster Pump #1 Field Performance Curve

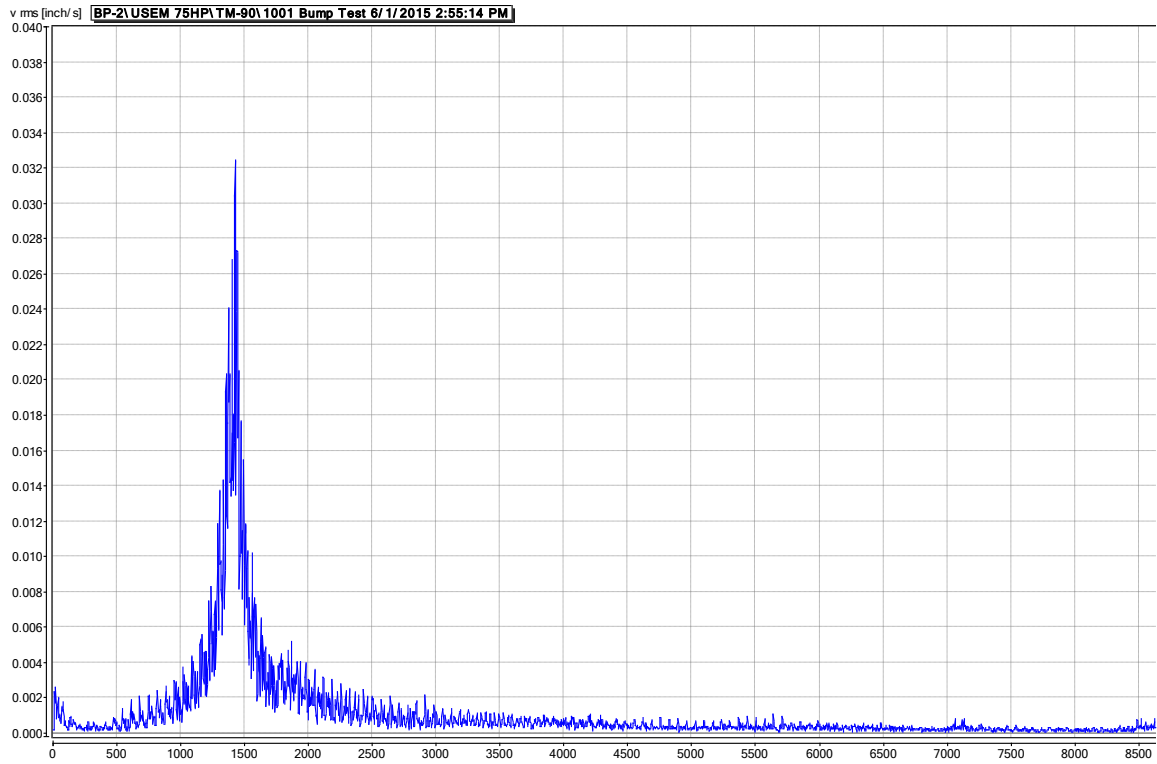
Figure 5: MT-90 Bump Test, Reed Frequency at 1,424 cpm, Motor Speed is 1,785 rpm

The reed frequency, as shown in Figures 5, is at 1,424 cpm 90 degrees to discharge which is 20% from run speed and should not cause any issues. The reed frequency, as shown in Figure 6, is at 1,789 cpm which is at run speed and will exacerbate and amplify any vibration.

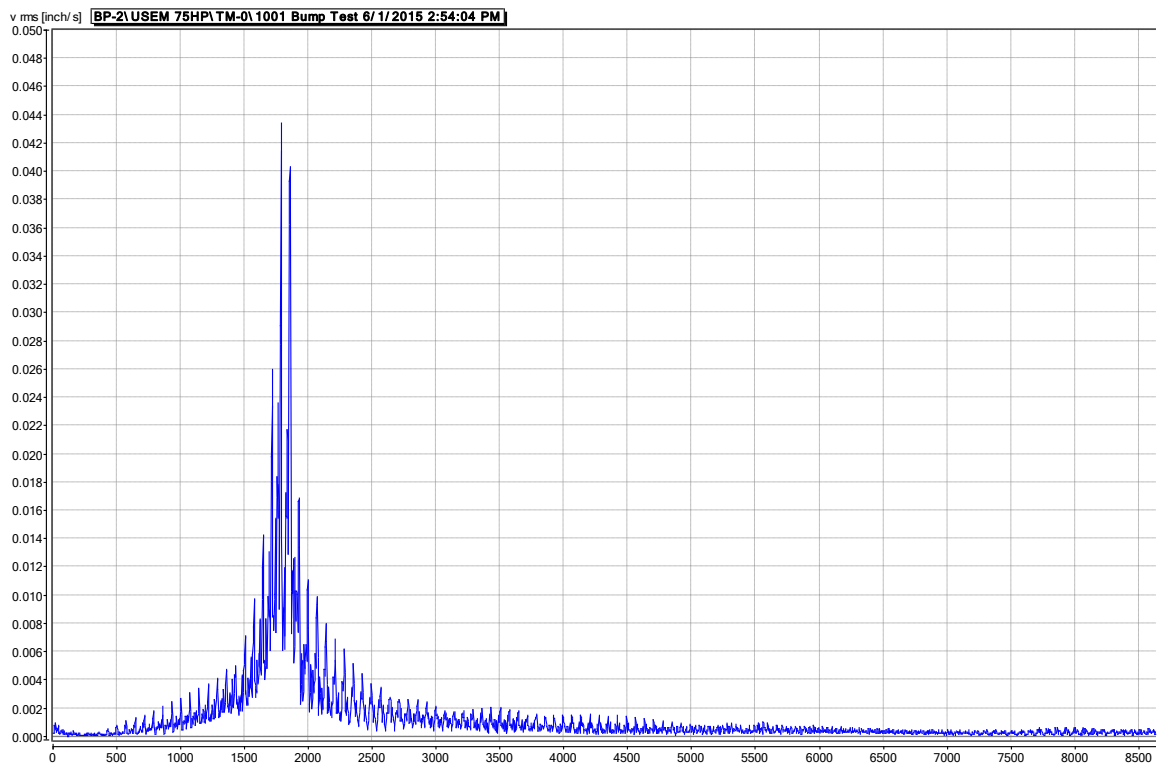
Figure 6: MT-0 Bump Test, Reed Frequency at 1,789 cpm, Motor Speed is 1,785 rpm

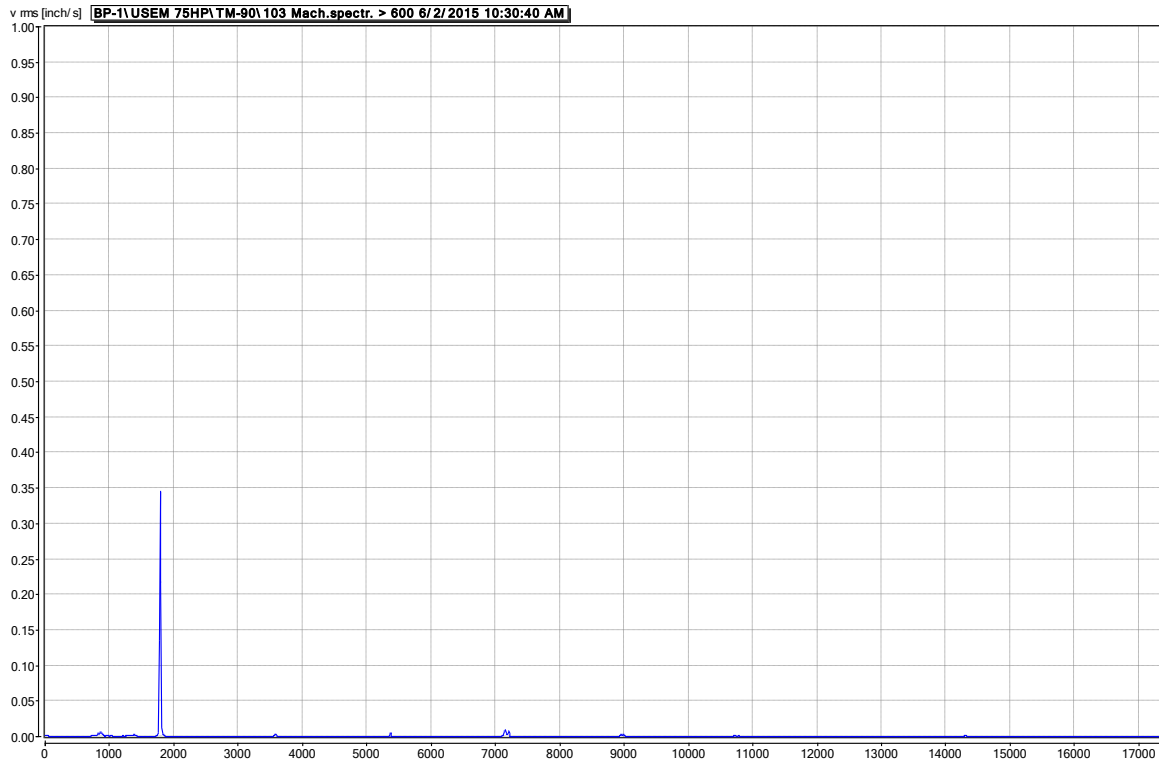
Figure 7: MT-90 Filtered Vibration, highest peak is 0.346 in/sec rms at 1,788 cpm (1X run speed)

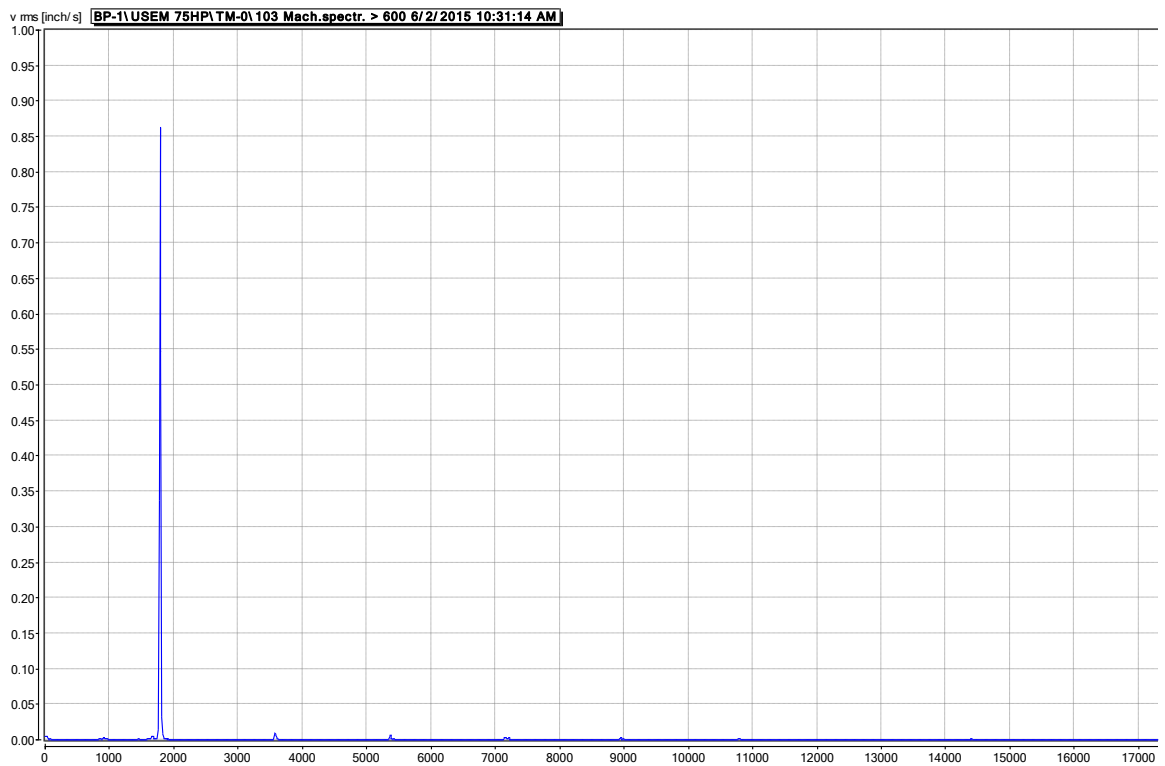
Figure 8: MT-0 Filtered Vibration, highest peak is 0.863 in/sec at 1,788 cpm (1X run speed)

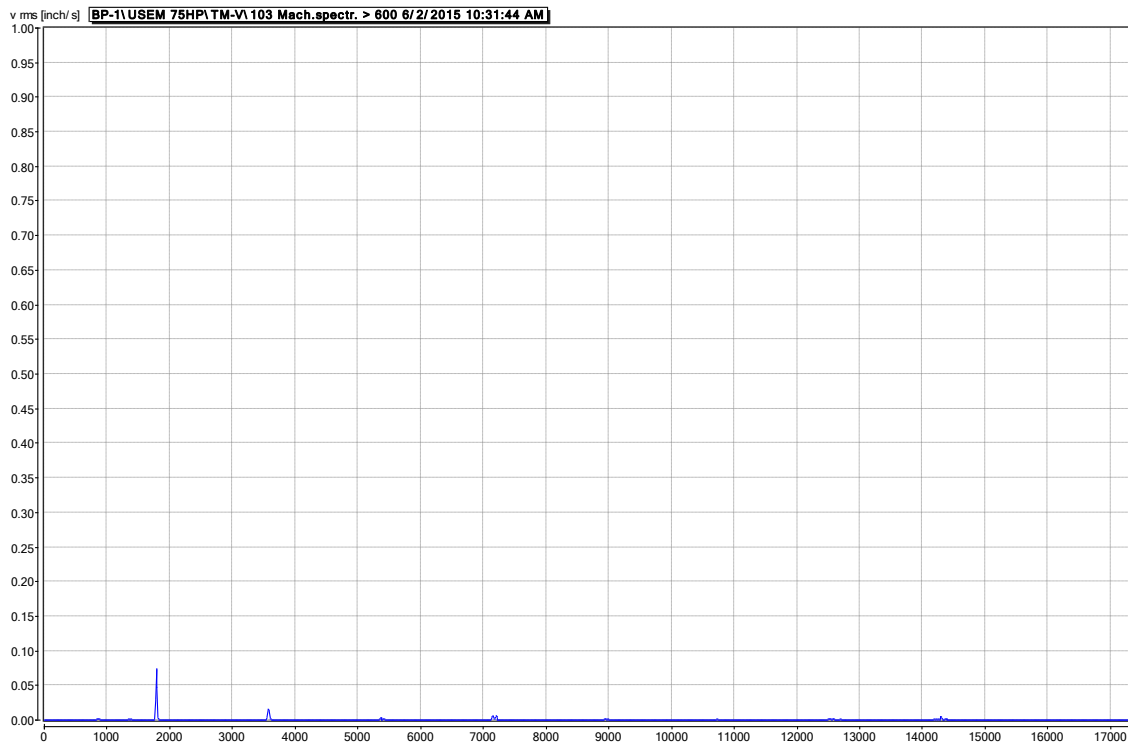
Figure 9: MT-V Filtered Vibration, highest peak is 0.074 in/sec at 1,788 cpm (1X run speed) and the next highest peak is 0.016 in/sec at 3,574 cpm (2X run speed)

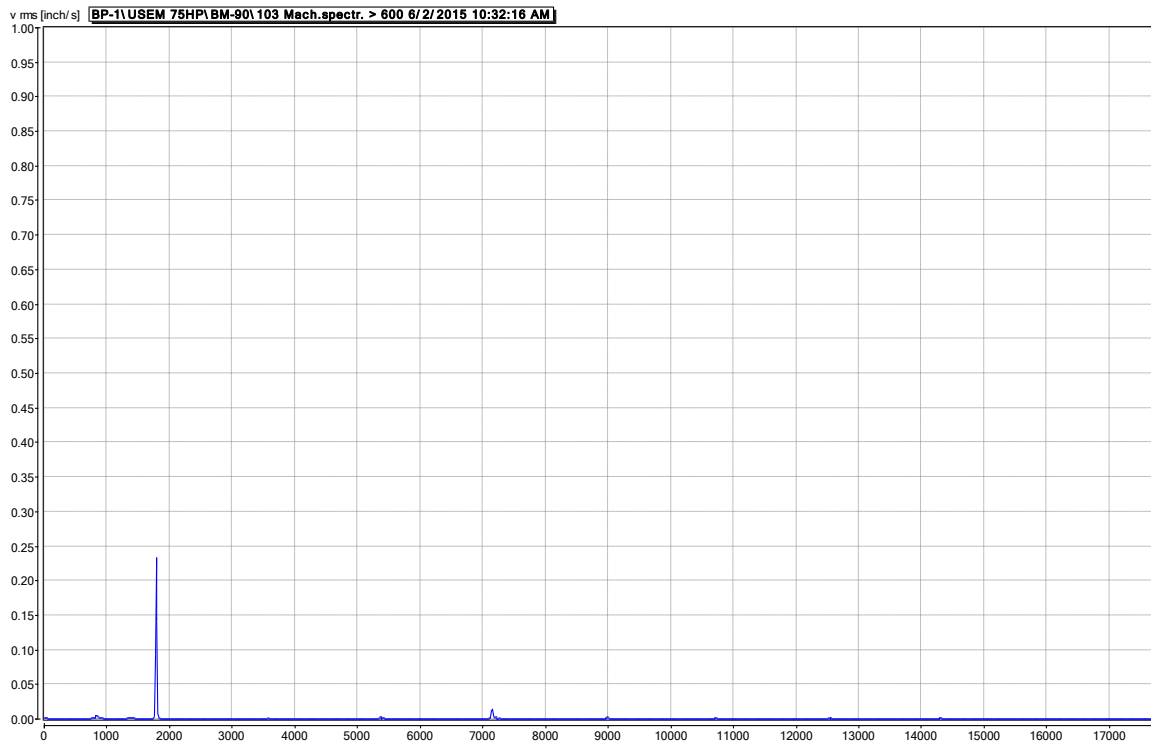
Figure 10: MB-90 Filtered Vibration, highest peak is 0.223 in/sec at 1,788 cpm (1X run speed), the next peak is 0.014 in/sec at 7,148 cpm (4X run speed)

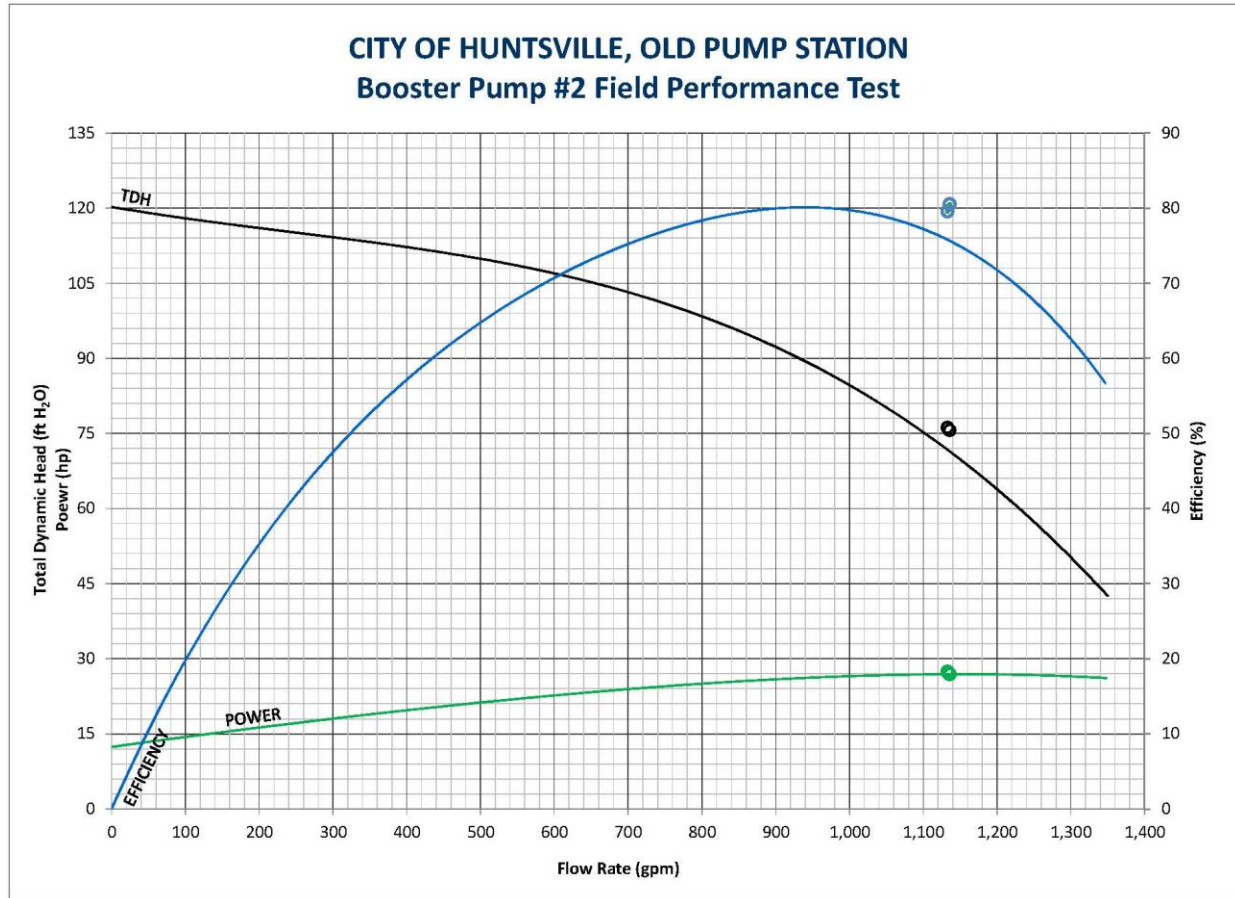
The composite curve below, Figure 12, shows the field data plotted with the curve provided by the city.

Figure 12: Old Booster Pump Station, Booster Pump #2 Field Performance Curve

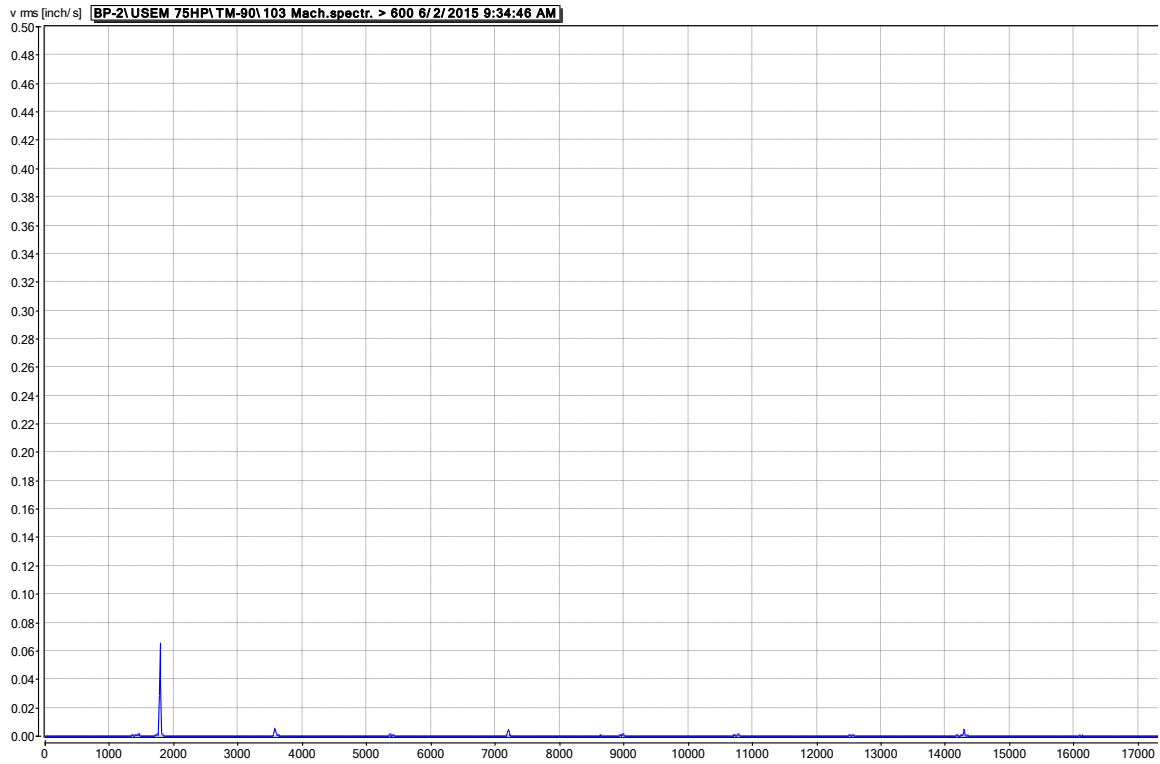
Figure 15: MT-90 Filtered Vibration, highest peak is 0.065 in/sec rms at 1,785 cpm (1X run speed)

The vibration at all of the locations has a dominant peak at 1X run speed. This is a typical signature of rotating equipment and indicates a slight imbalance and/or misalignment or looseness. The amplitude is very high at the locations that are in-line with the discharge and should be corrected. Field balancing may resolve the issue but it may be caused by loose pump bearings which would require the pump to be pulled and repaired

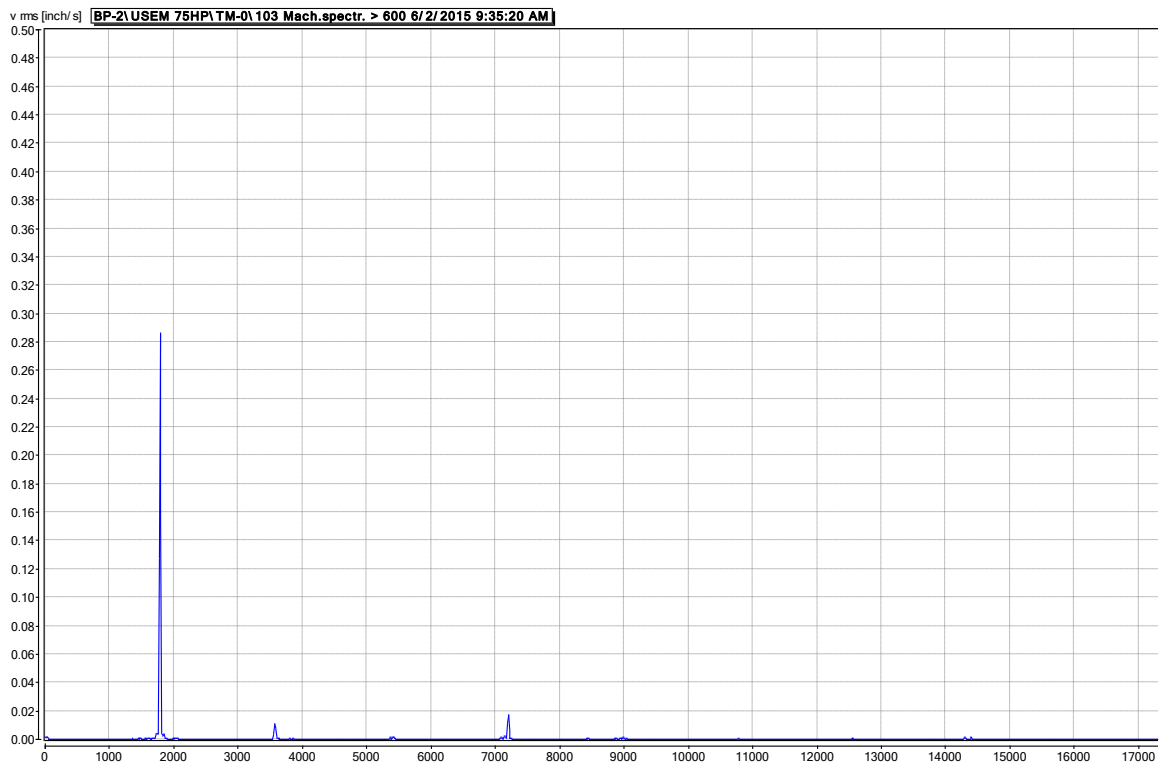
Figure 16: MT-0 Filtered Vibration, highest peak is 0.286 in/sec at 1,785 cpm (1X run speed) and the next highest peak is 0.017 in/sec at 7,196 cpm (4X run speed)

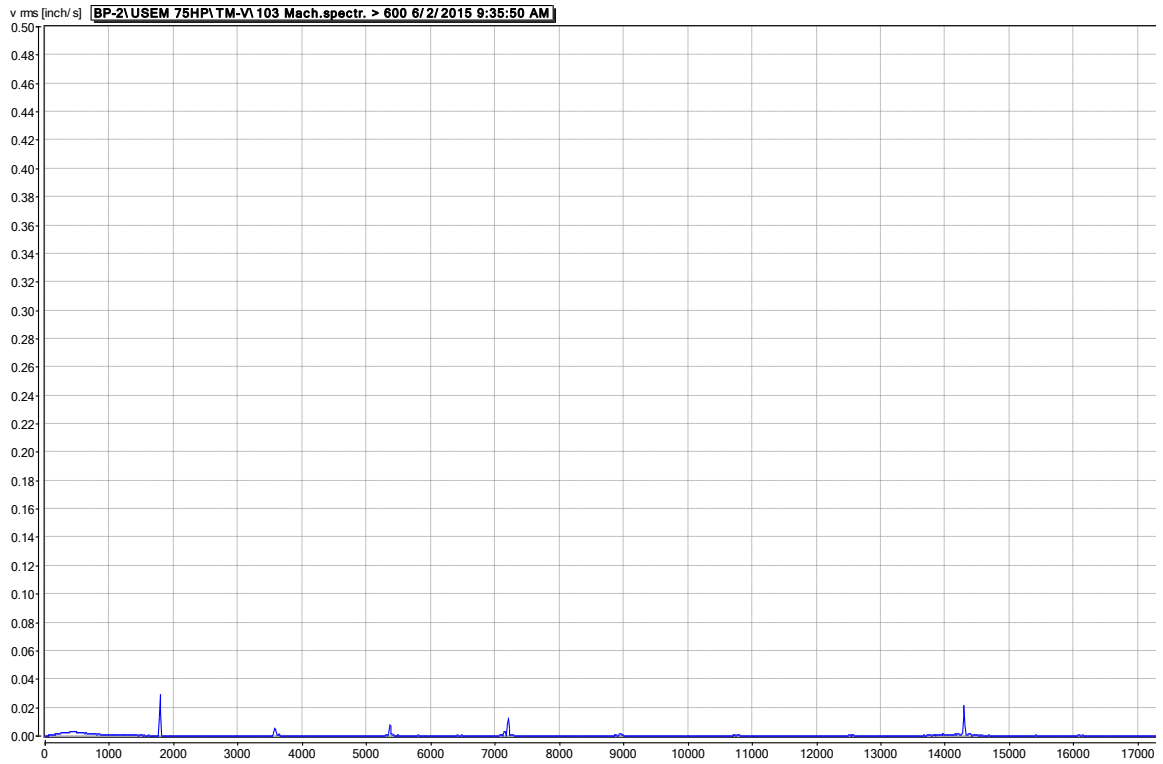
Figure 17: MT-V Filtered Vibration, highest peak is 0.029 in/sec at 1,785 cpm (1X run speed) and the next highest peak is 0.021 in/sec at 14,291 cpm (8X run speed)

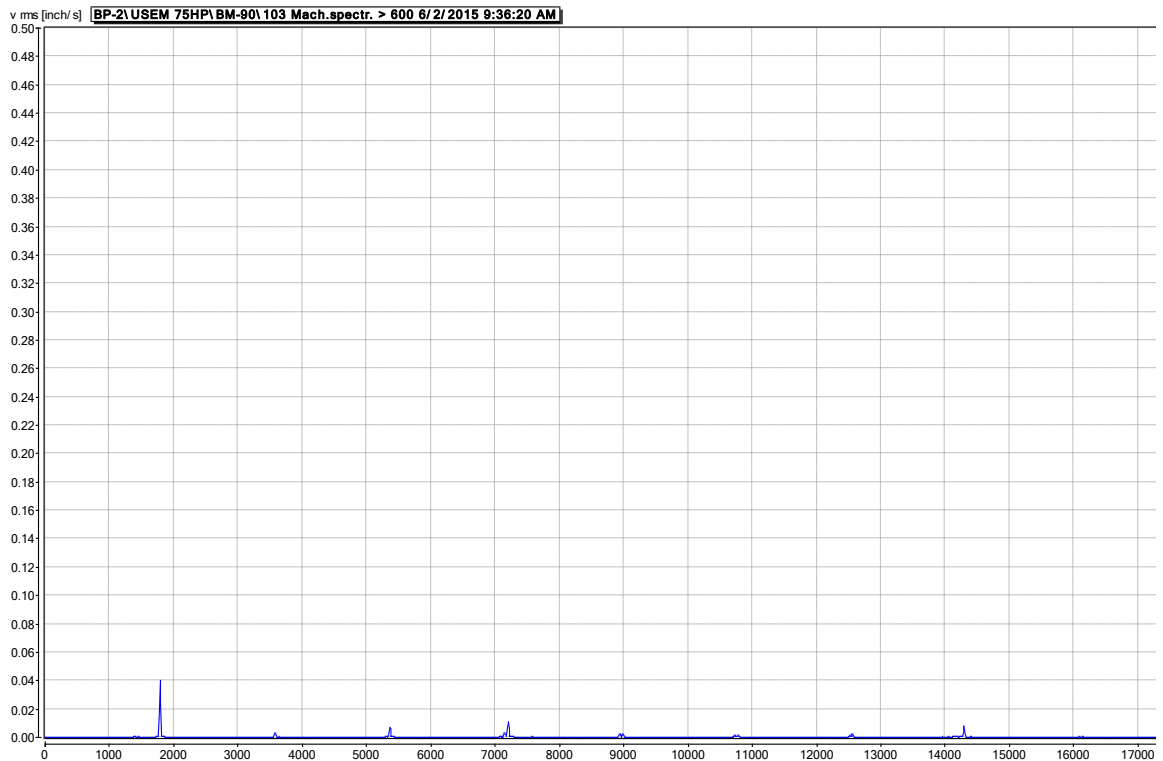
Figure 18: MB-90 Filtered Vibration, highest peak is 0.040 in/sec at 1,785 cpm (1X run speed)

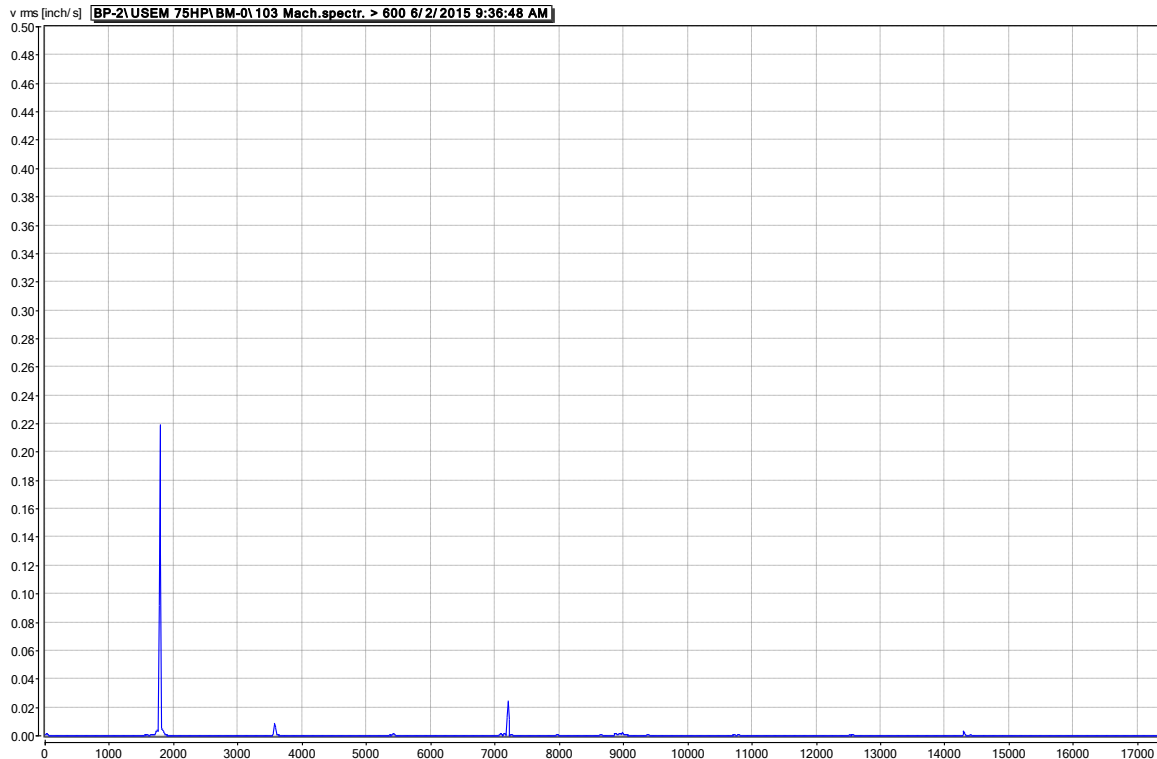
Figure 19: MB-0 Filtered Vibration, highest peak is 0.219 in/sec at 1,785 cpm (1X run speed) and the next highest peak is 0.025 in/sec at 7,200 cpm (4X run speed)

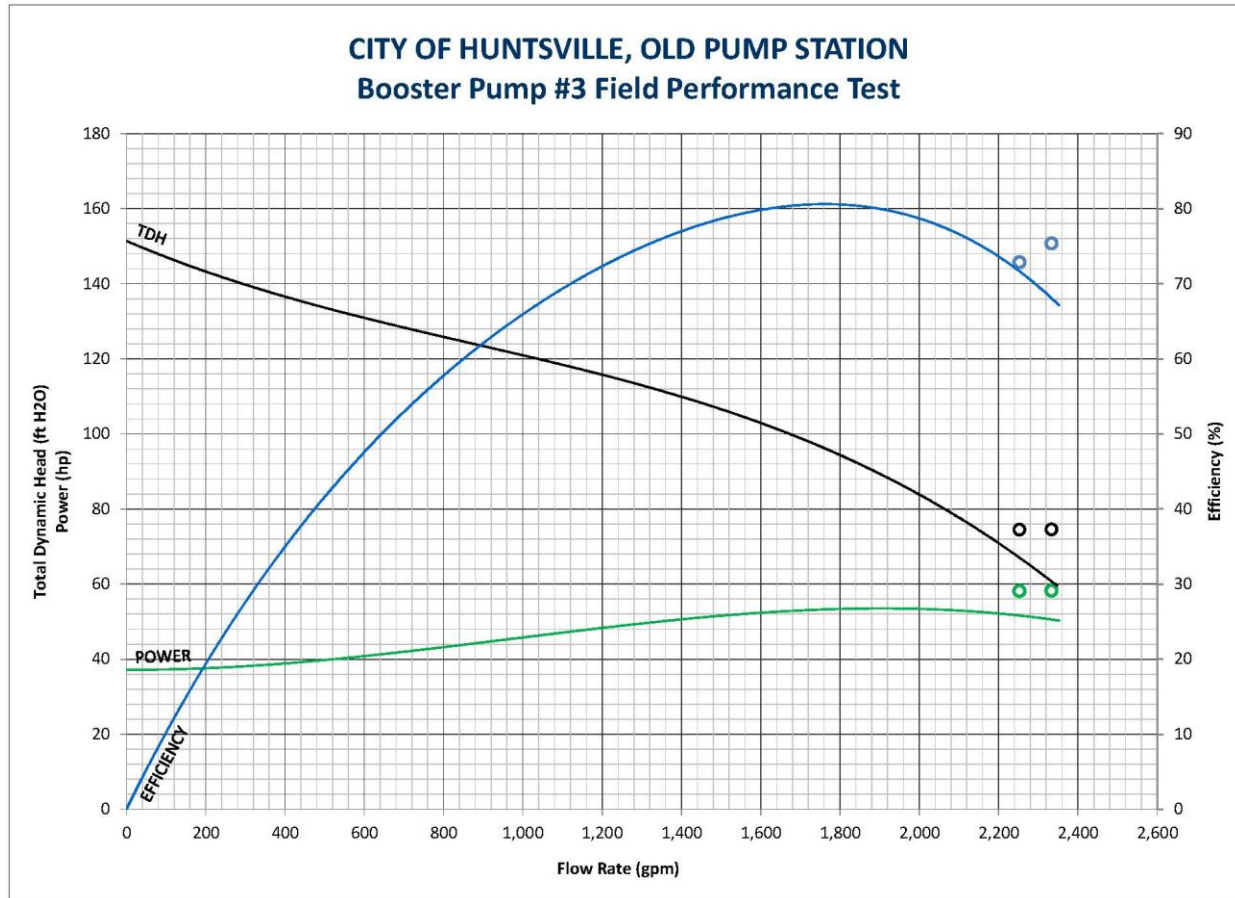
The composite curve below, Figure 20, shows the field data plotted with the curve provided by the city.

Figure 20: Old Booster Pump Station, Booster Pump #3 Field Performance Curve

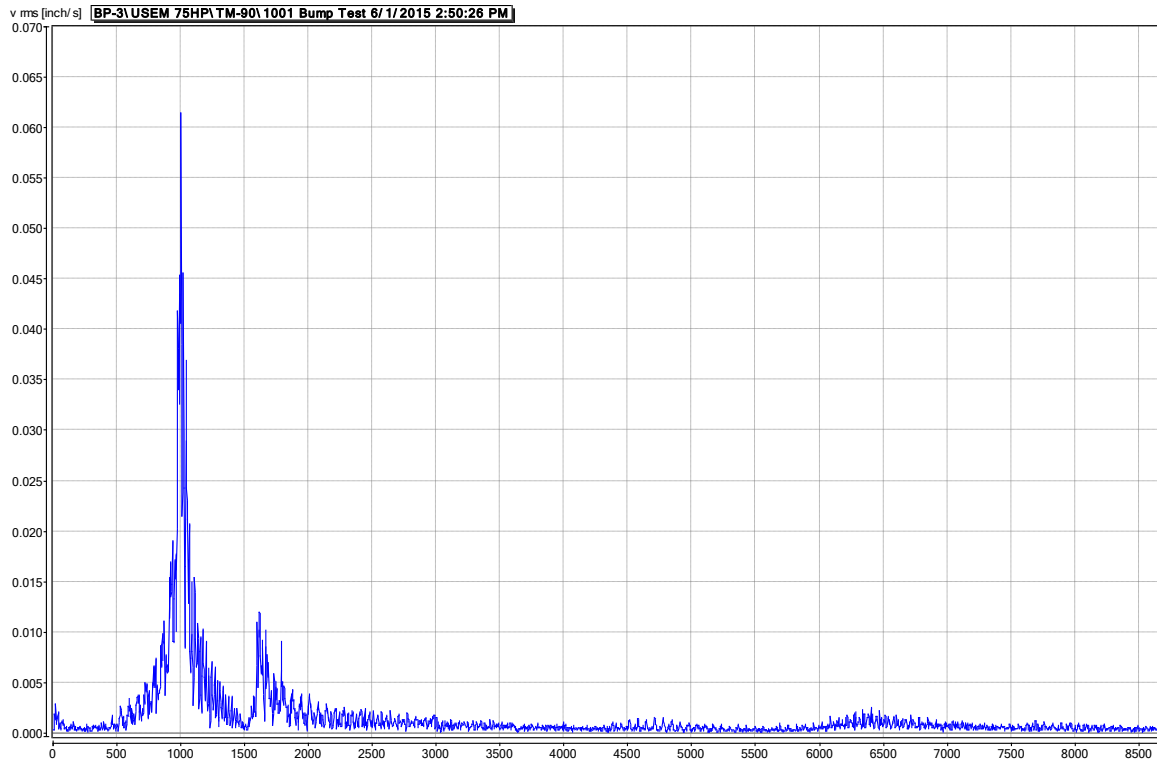
Figure 21: MT-90 Bump Test, Reed Frequency at 1,002 cpm, Motor Speed is 1,785 rpm

The reed frequency, as shown in Figures 21, is at 1,002 cpm 90 degrees to discharge which is 44% from run speed and should not cause any issues. The reed frequency, as shown in Figure 22, is at 1,291 cpm which is 28% from run speed and should not cause any issues.

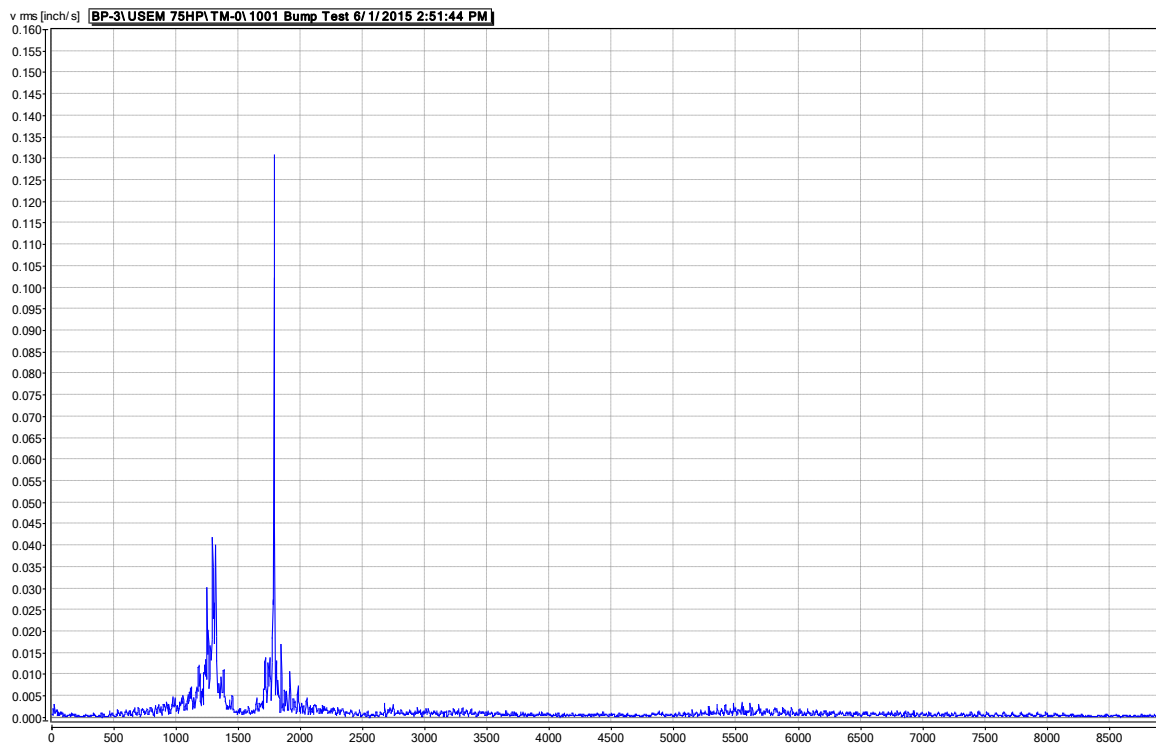
Figure 22: MT-0 Bump Test, Reed Frequency at 1,291 cpm, Motor Speed is 1,785 rpm. The highest peak is from the sister unit running while this unit was being bump tested.

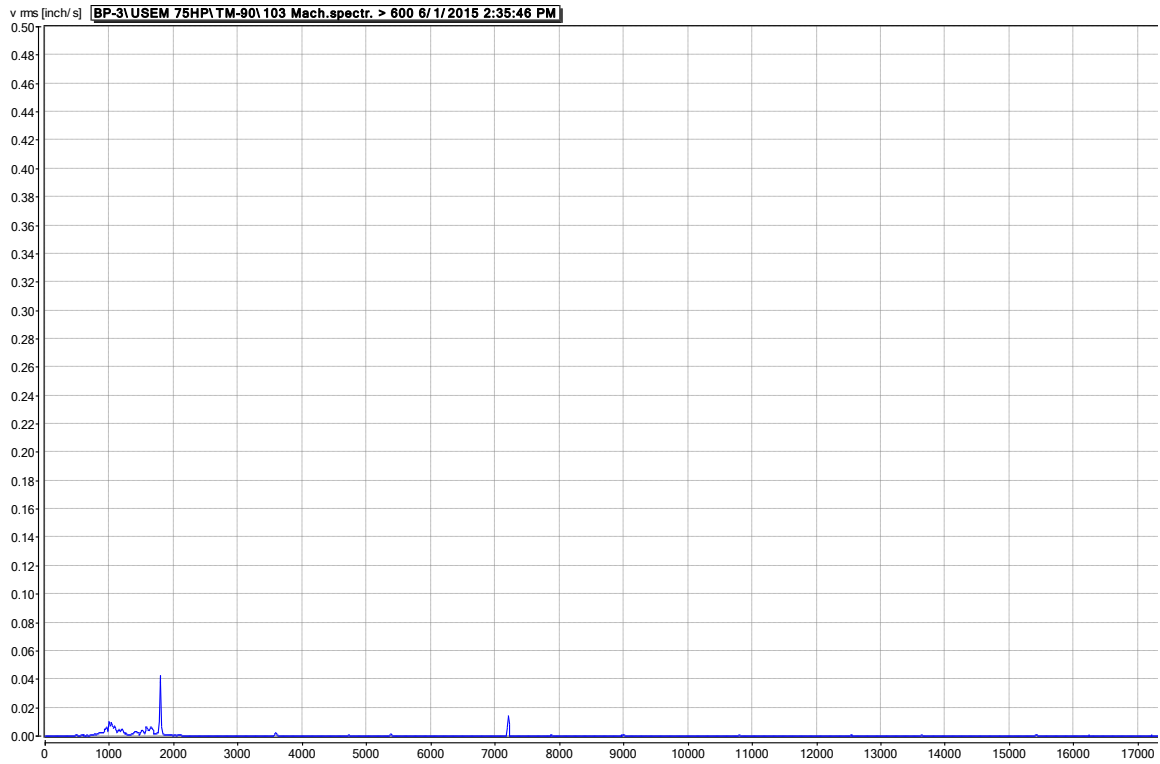
Figure 23: MT-90 Filtered Vibration, highest peak is 0.042 in/sec rms at 1,792 cpm (1X run speed)

The vibration at all of the locations has a dominant peak at 1X run speed. This is a typical signature of rotating equipment and indicates a slight imbalance and/or misalignment or looseness. The amplitude for the most part is low but the vibration at the top of the motor in-line with the discharge is slightly above the HI limits. Field balancing would likely resolve this issue.
